Rimkus Consulting Group, Inc.
Eight Greenway Plaza, Suite 500
Houston, TX 77046
(800) 580-3228 Telephone
(713) 623-4357 Facsimile

Re: RCG File No: 11009971
LLV Number: 0209452
VMF Location: 1530 Greensmark Drive in Houston, Texas
Subject: Final Report

Rimkus Consulting Group, Inc. was retained to examine LLV 0209452, VIN 1GBCS10E4M2908832. The fire occurred on June 13, 2016 at around 12:30 P.M. the operator of the vehicle at the time of the fire, was unavailable for interview but reportedly stated the vehicle's engine died while delivering mail on his route and backfired during subsequent attempts to restart it. Soon thereafter, smoke was observed from beneath the hood as well as flames.

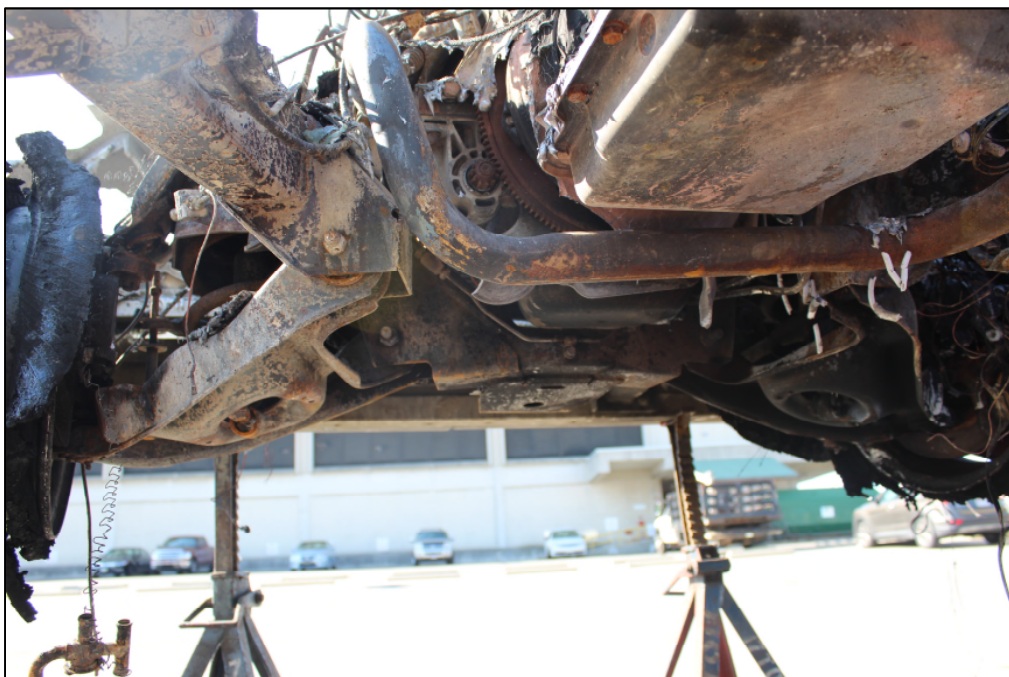
The GM frame under the vehicle was intact. The top side of the frame was fire damaged. The exhaust system was relatively intact.

Photograph 8
Undercarriage.

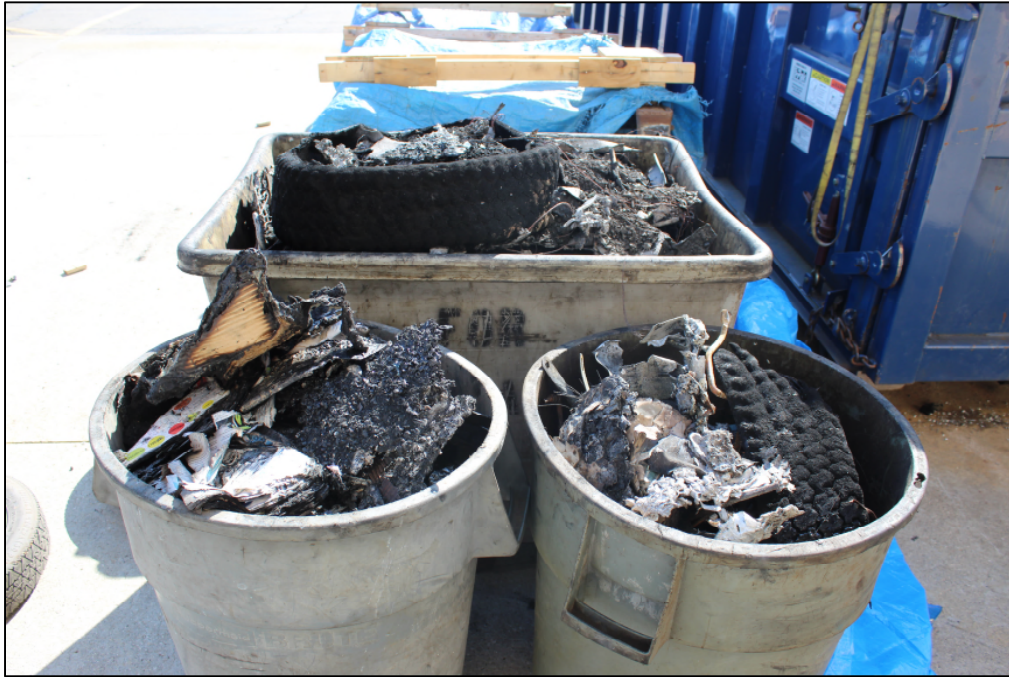
Photograph 9

Fire debris and parts collected from fire scene.

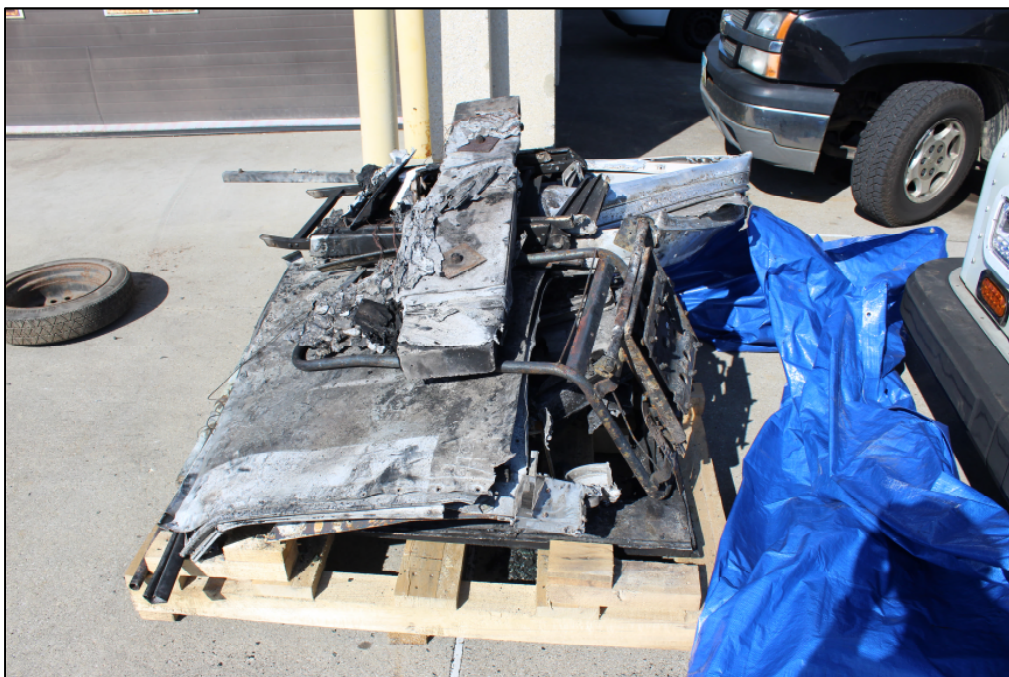
Photograph 10

Fire damaged structural parts collected from fire scene.

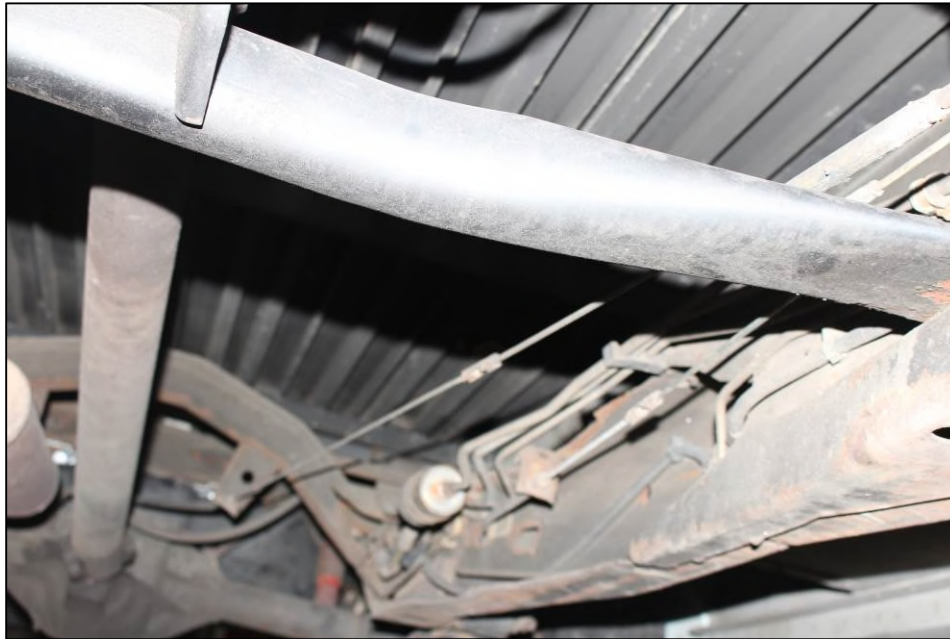
Photograph 7

Fuel filter along frame in back left of vehicle.

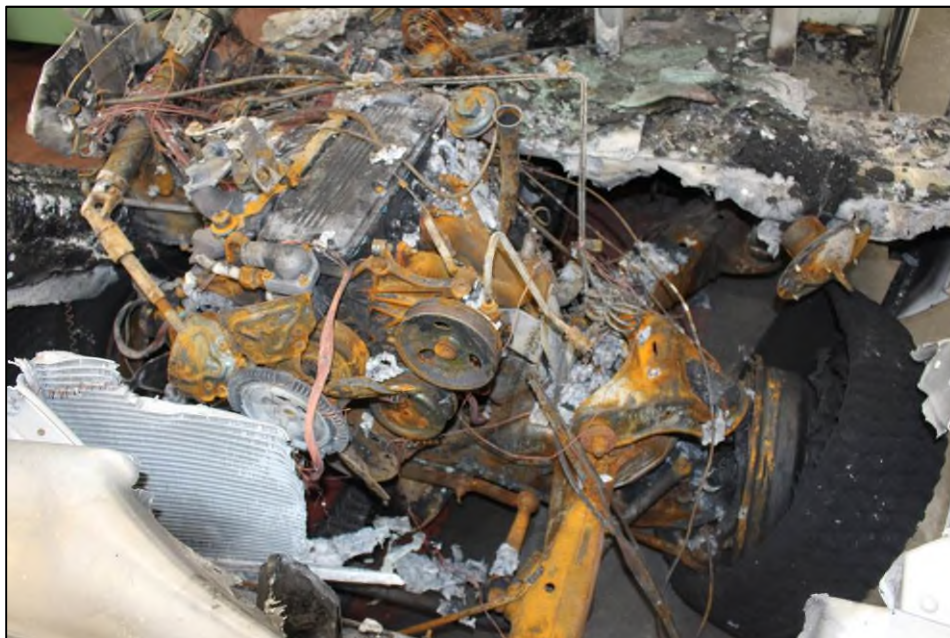
Photograph 8

Overview of engine compartment.

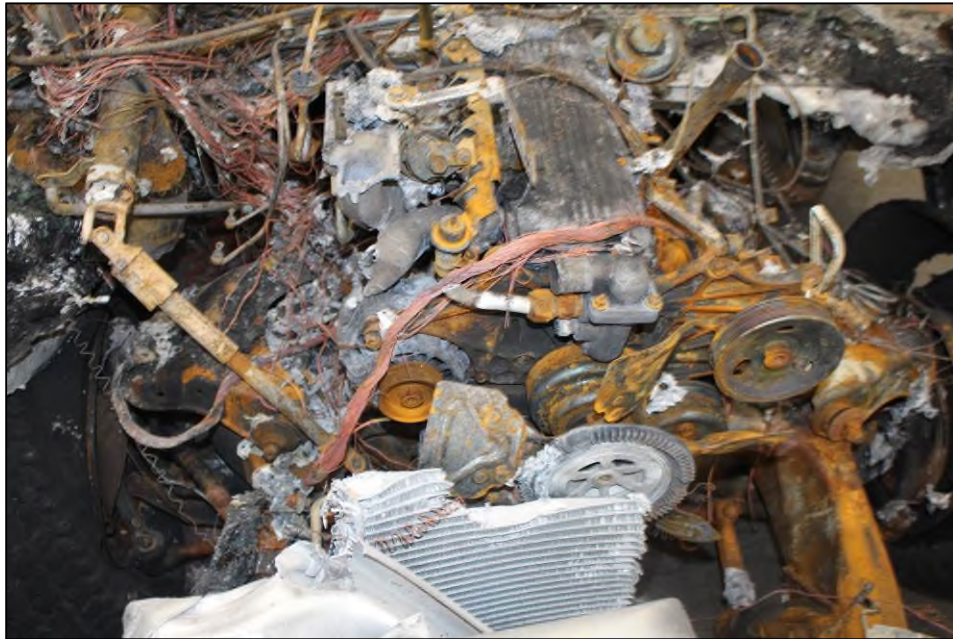
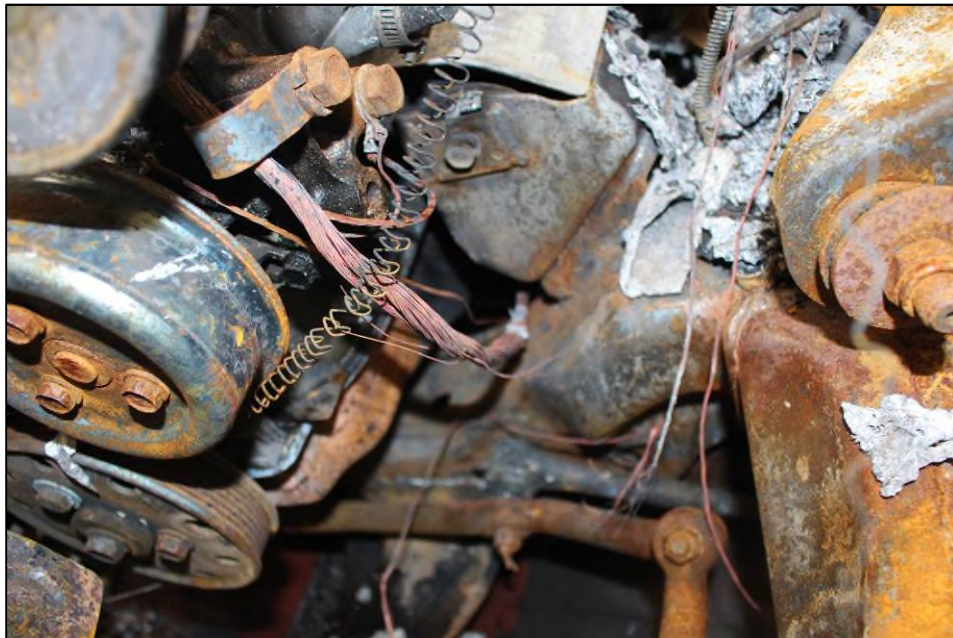
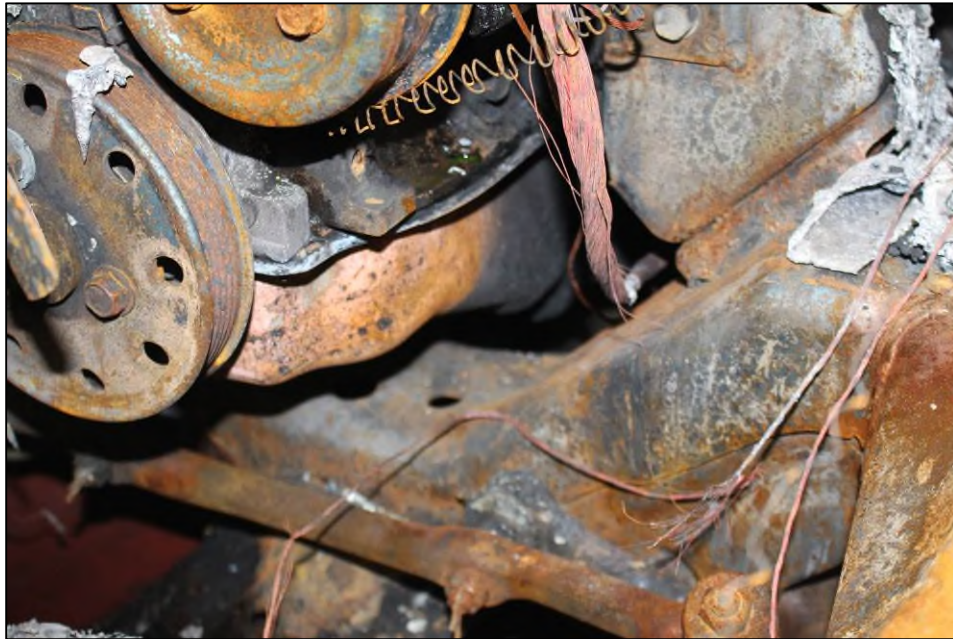
Photograph 9
Starter cable.

Photograph 10
Starter cable.

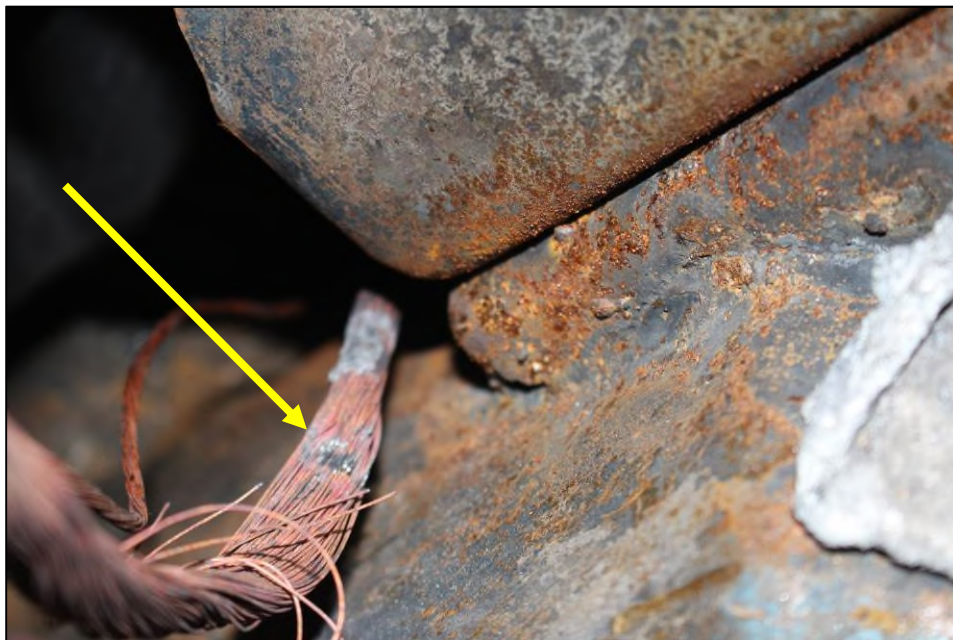
3. The specific ignition sequence and cause of the fire was determined to be the direct result of damage to the positive conductor routed to the starter which came into direct contact with the metal frame and caused an adverse electrical event which ignited available combustible materials.

Photograph 10
Starter cable pinched and broken.

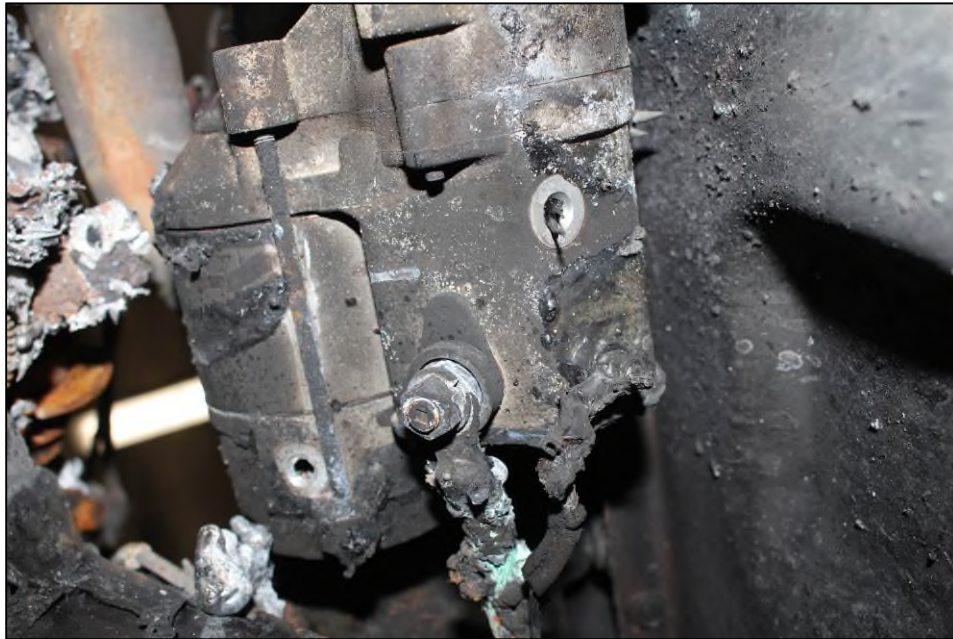
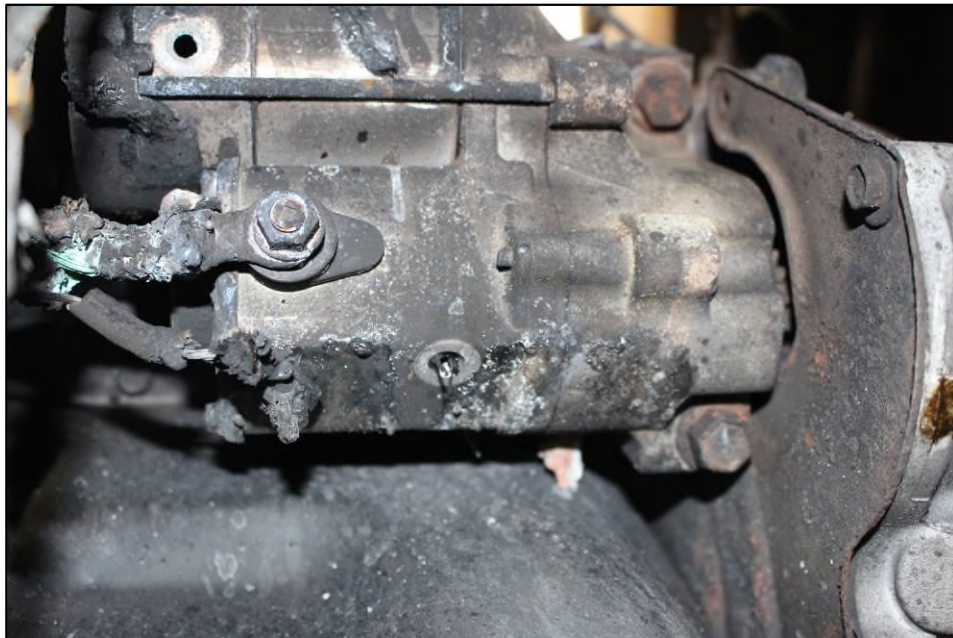
A review of the provided service records for the involved LLV was conducted. The starter for the LLV was replaced in September 2016 prior to the fire. There were no other repairs indicated that would have caused or contributed to the cause of the fire.

Photograph 11
Starter.

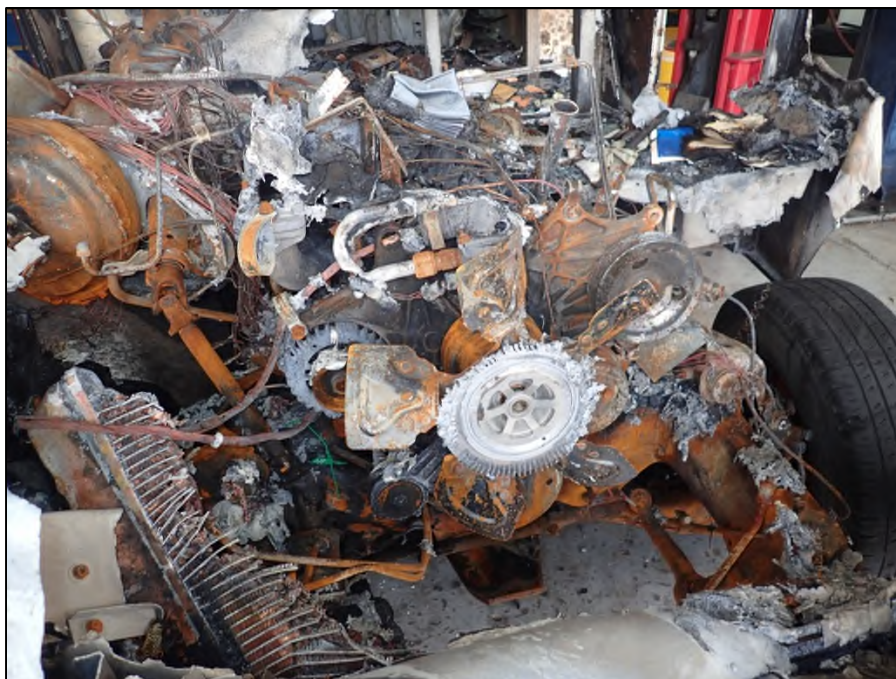
Photograph 3

A view of the engine of the vehicle.

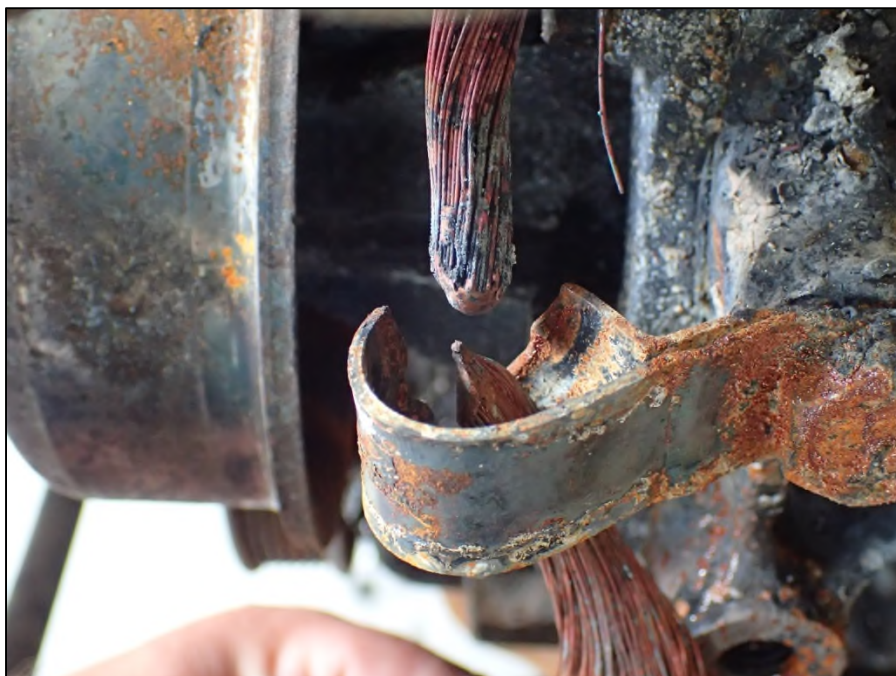
Photograph 4

Damage to the cable leading from the battery to the starter.

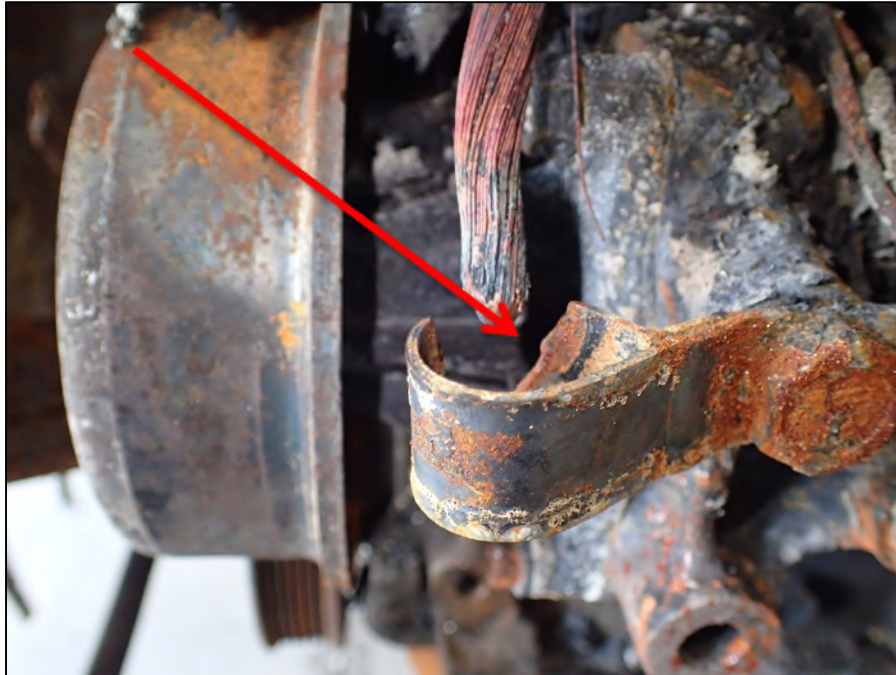
Photograph 5

Visible damage to bracket holding cable.

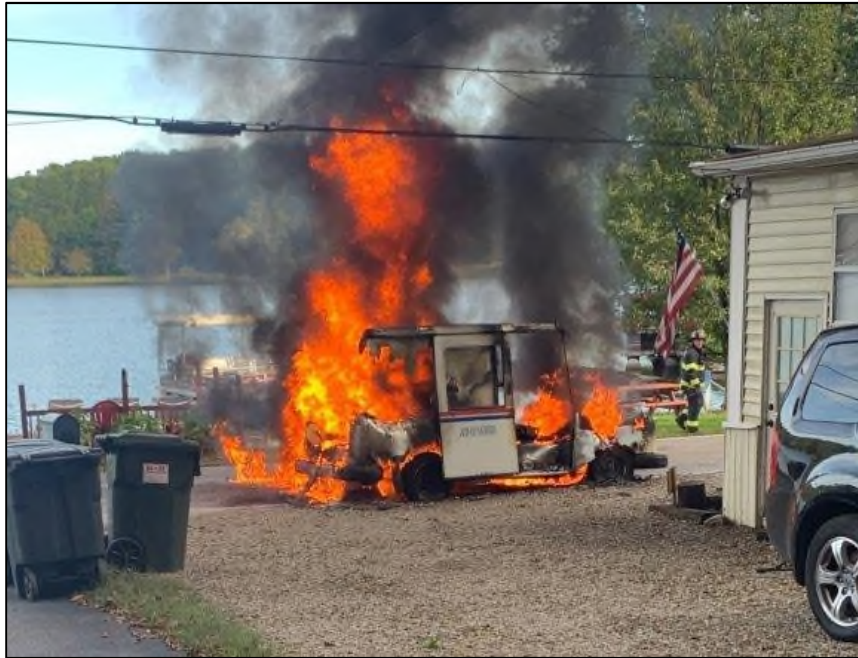
Photograph 1

Carrier photo of the fire scene.

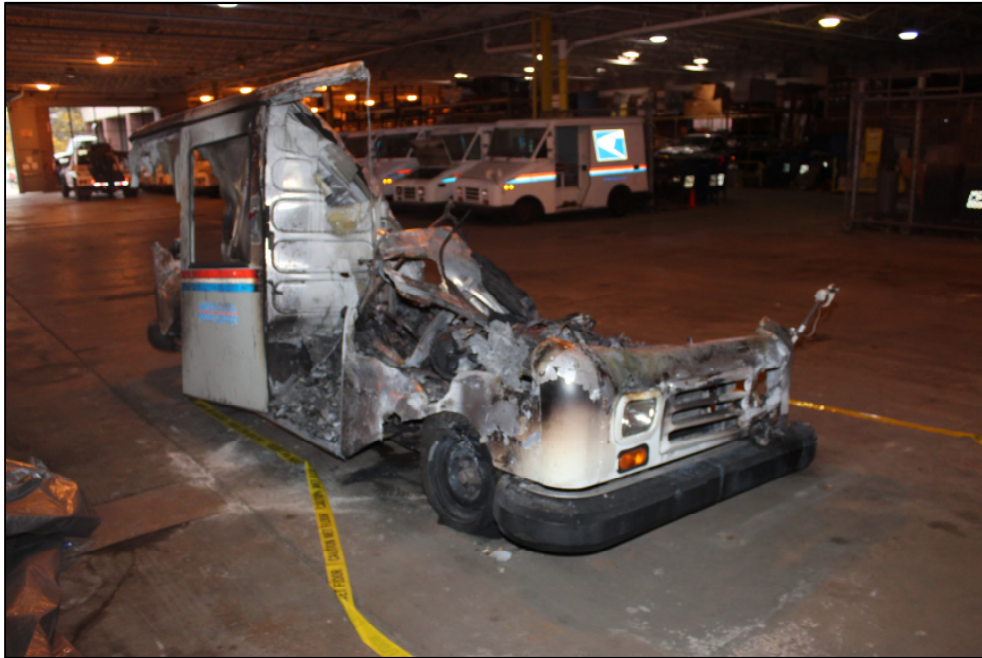
The body of the vehicle was destroyed by fire. There was a small amount of the driver side body wall still intact and vertical. The driver door was in place in the open position, with fire damage and deformity. All tires were fire damaged, flattened, and partially consumed by fire. The doors were deformed and collapsed.

Photograph 3
Driver side.

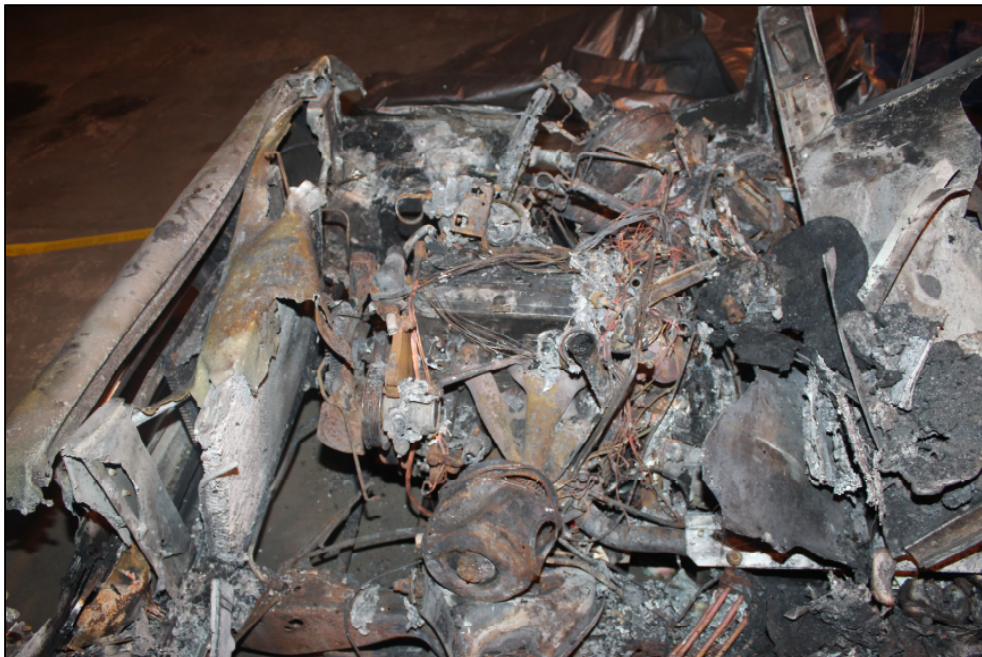
The engine compartment was severely damaged. Fire patterns observed in the engine compartment indicated the area of fire origin was the dashboard area. According to the VMF manager, the engine was a 2.2 liter with fuel injection and high output coil.

Photograph 6
Engine compartment.

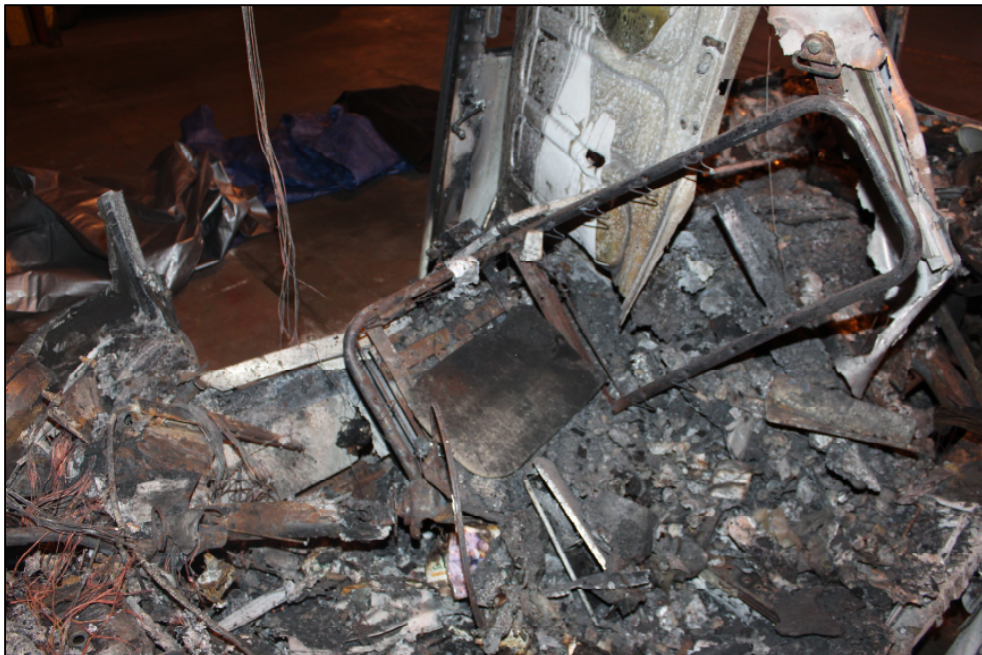
Based on the patterns observed and data gathered from the interview with the VMF manager, the area of fire origin was the left side of the interior under the dashboard.

Photograph 8
Driver compartment.

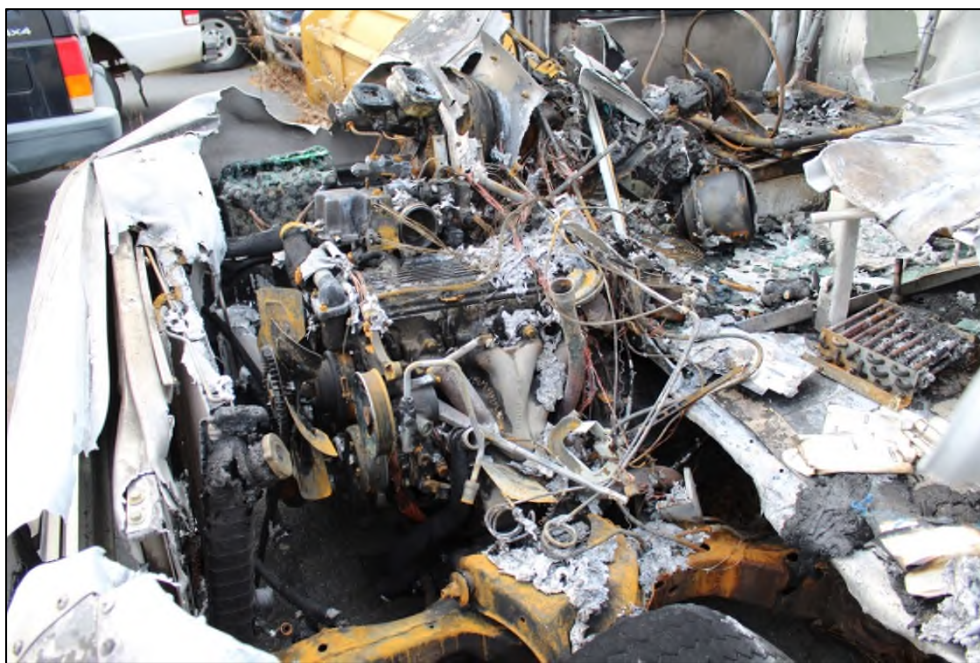
Photograph 5

The fuel line was intact from the fuel filter positioned at the bulkhead. Burn patterns observed in the engine compartment confirmed the fire originated in the front left area of the engine compartment and progressed upward and outward throughout the engine compartment.

View of the engine compartment.

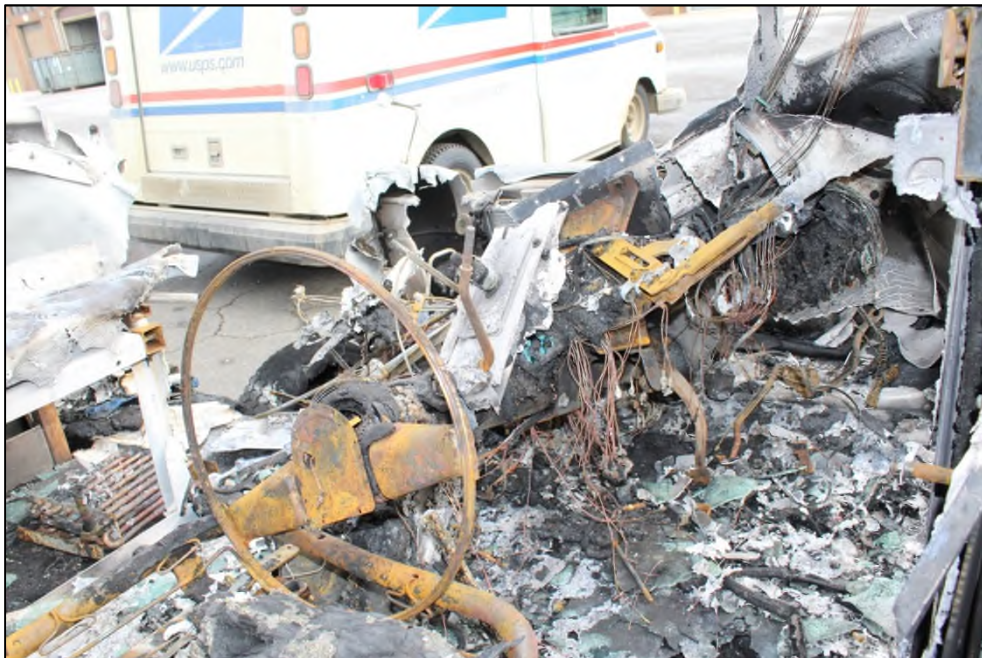
Photograph 8

The interior examination of the vehicle revealed that the dashboard had sustained severe damage. The fire originated in the engine compartment and entered the operators' area through the bulkhead and windshield, causing severe damage to this area. The cargo area displayed moderate fire damage. The ECM had displayed severe fire damage.

View of the dash area.

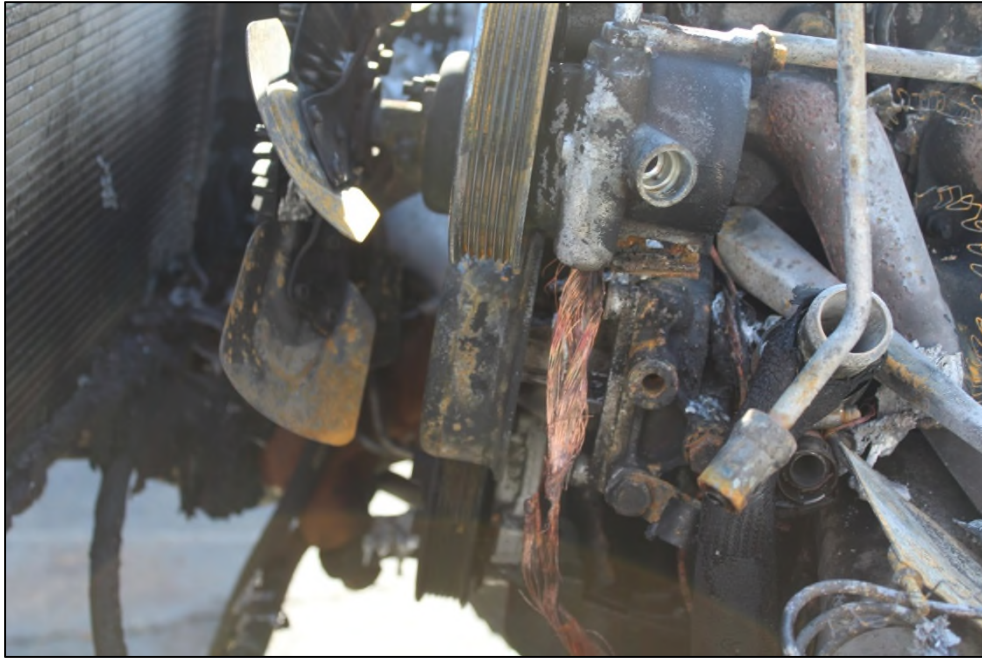
Photograph 11

3. The specific ignition sequence and cause of the fire was determined to be an adverse electrical event at the large diameter battery cable that was identified routed through a retaining clamp below the power steering pump. The cable exhibited physical evidence consistent with adverse electrical activity and the cable was severed at the retaining clamp. The retaining clamp exhibited physical evidence consistent with adverse electrical activity and arcing. The source of the fire's ignition was resistance heating of the battery cable caused by a direct short between the cable and the retaining ring.

4. Wear and degradation of components allowed an unfused adverse electrical event to develop at the battery hot lead where it was in direct contact with the retaining clamp below the power steering pump within the engine compartment.

View of the electrical cable involved – the cable extends from the battery to the starter.

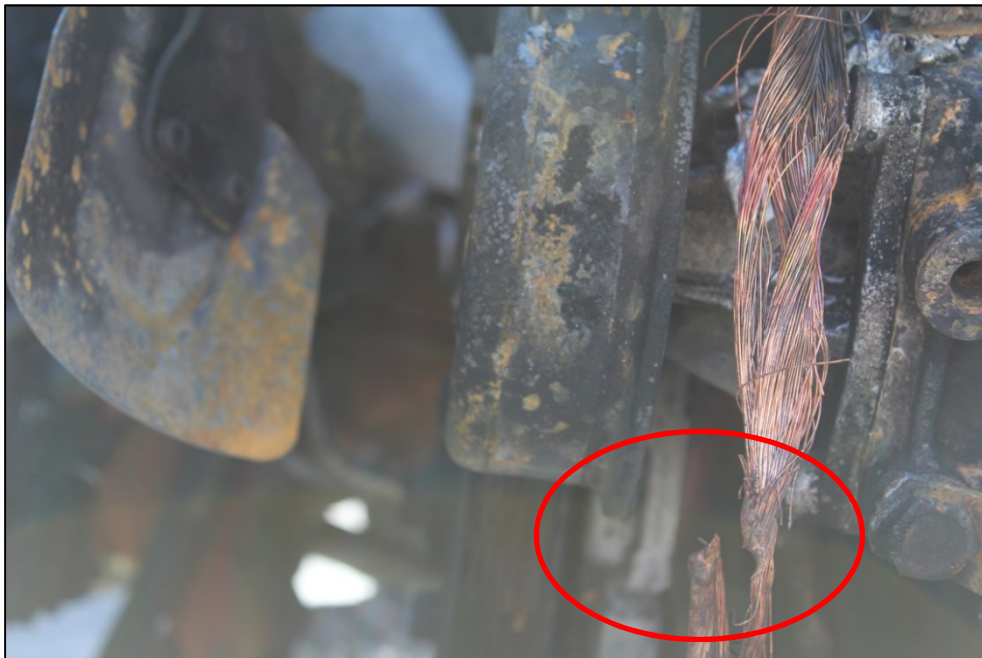
Photograph 12

Close-up view of the damage to the cable.

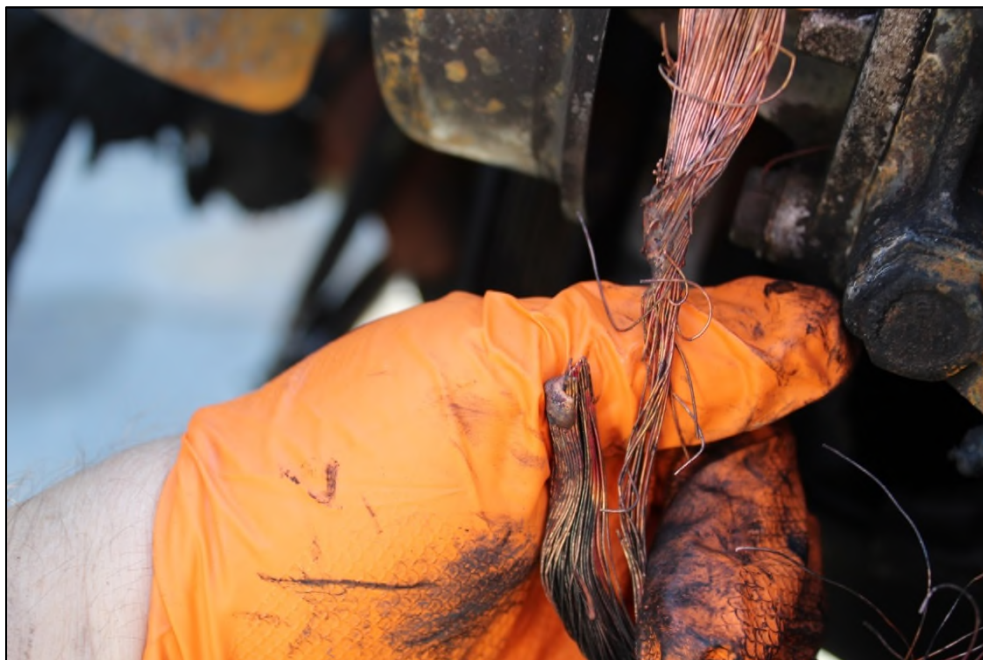
Photograph 14

Close-up of damage to the cable.

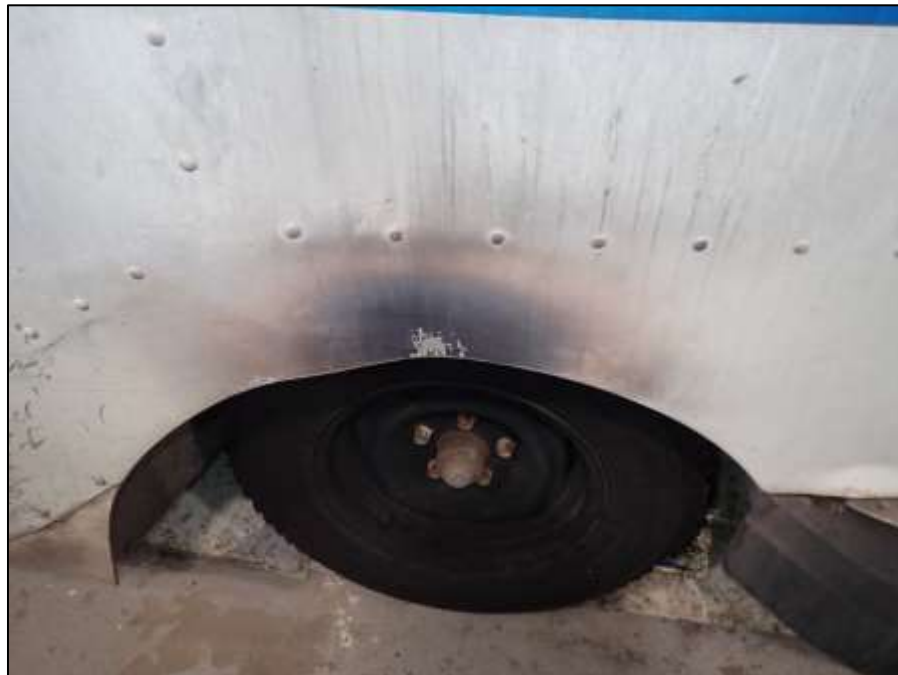
Photograph 2

Burn patterns to right front fender.

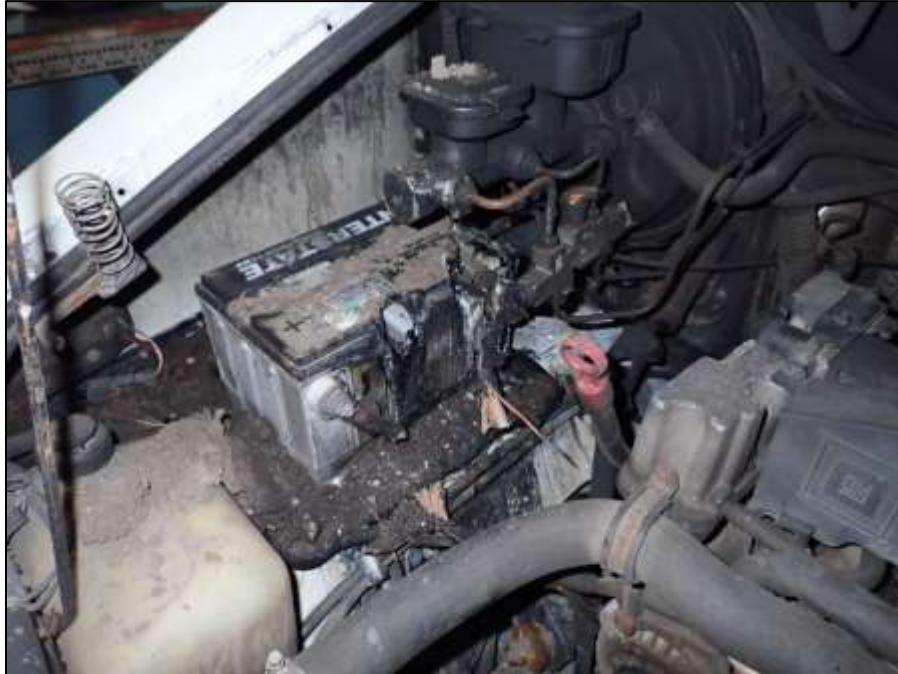
Photograph 3

Area of origin at battery.

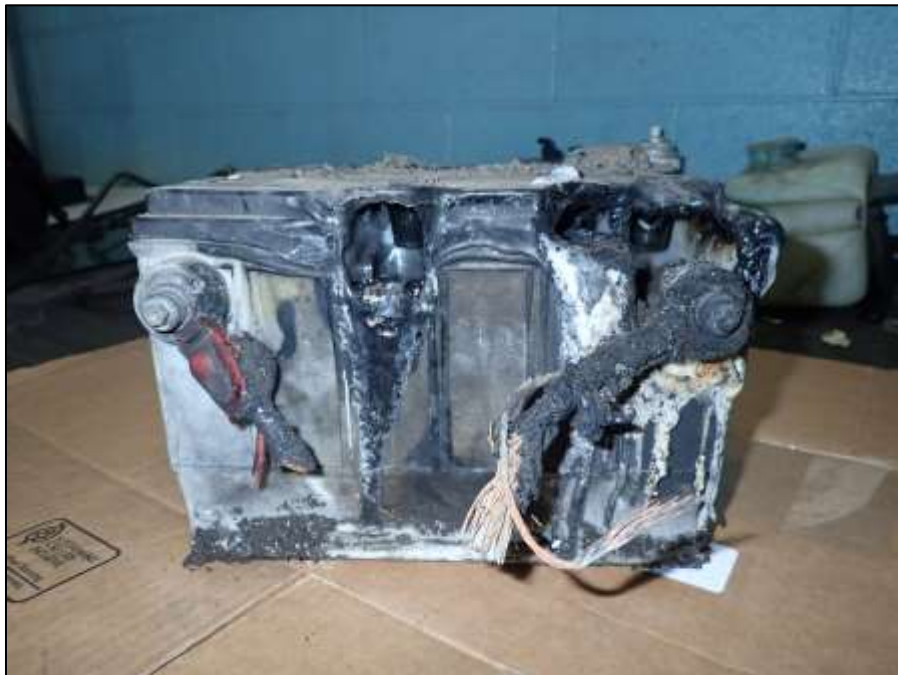
Photograph 4

Fire damage at negative side of battery.

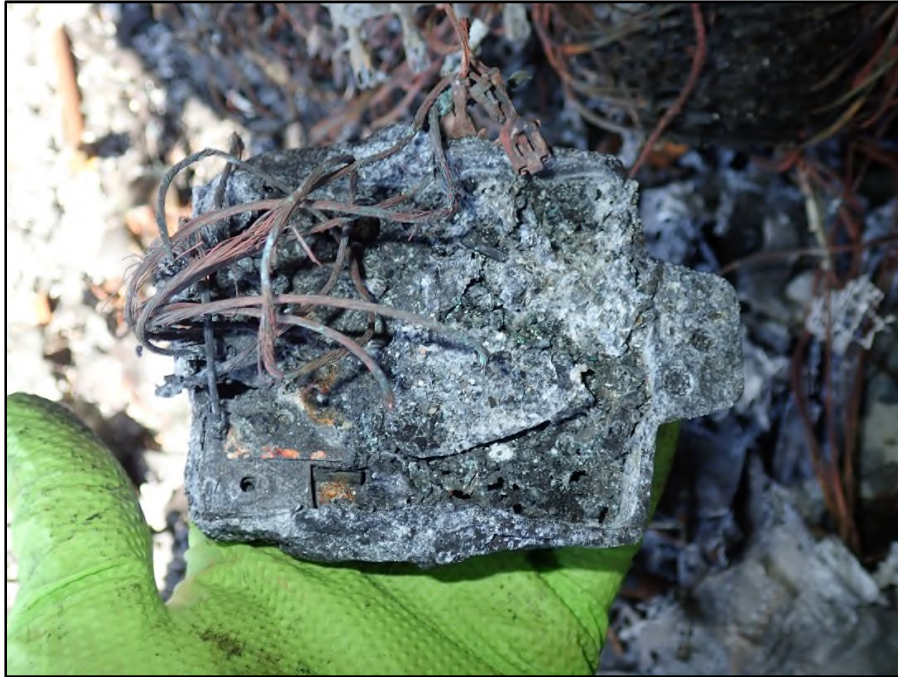
Photograph 7

View of the remains of the fuse panel at the right side of the dash.

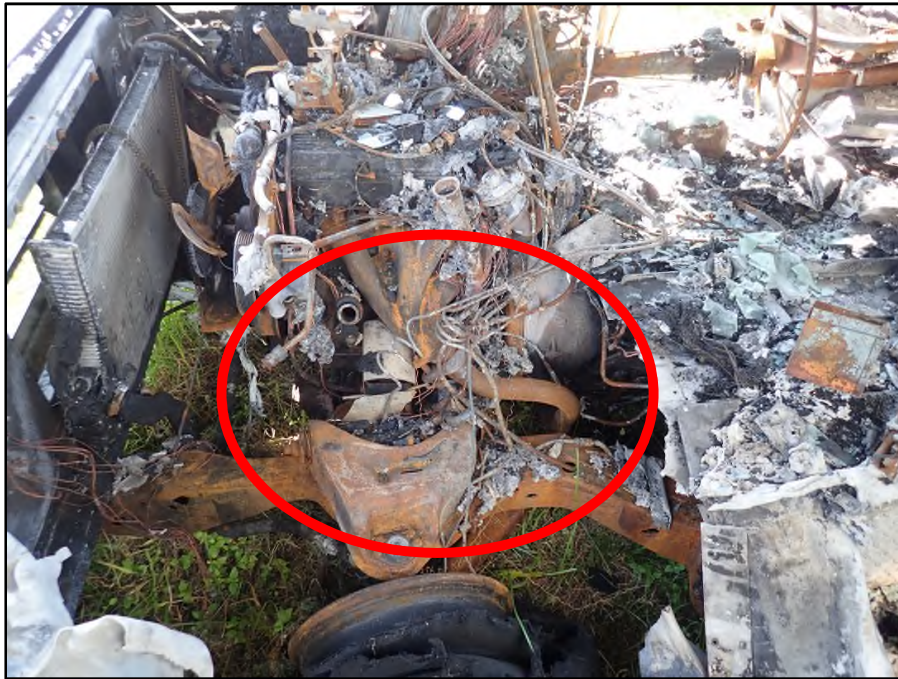
Photograph 9

View of the left side of the engine compartment with the origin area notated.

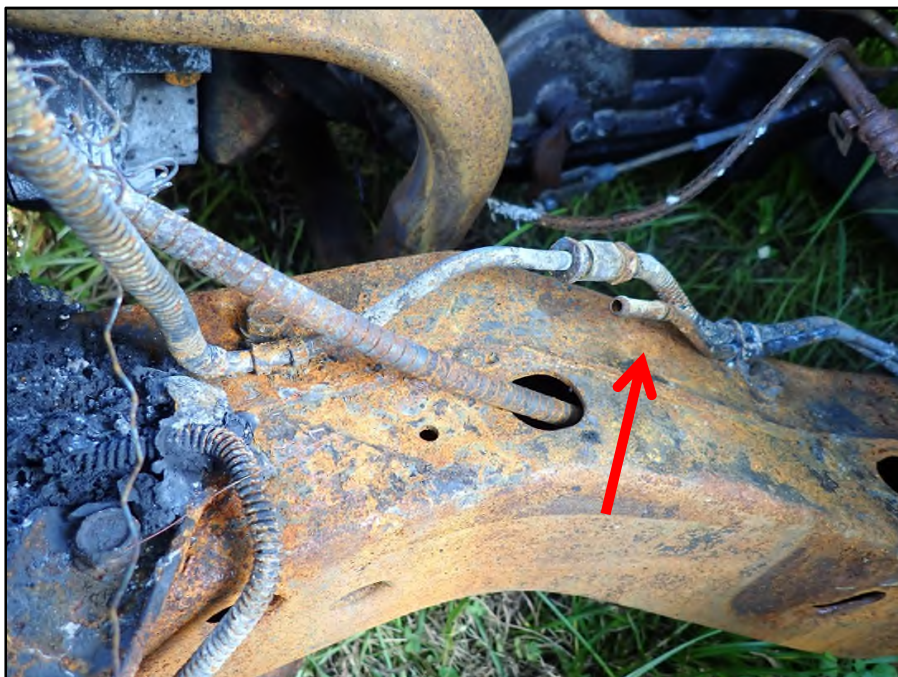
Photograph 10

View of the rigid fuel line as it enters the engine compartment along the frame rail.

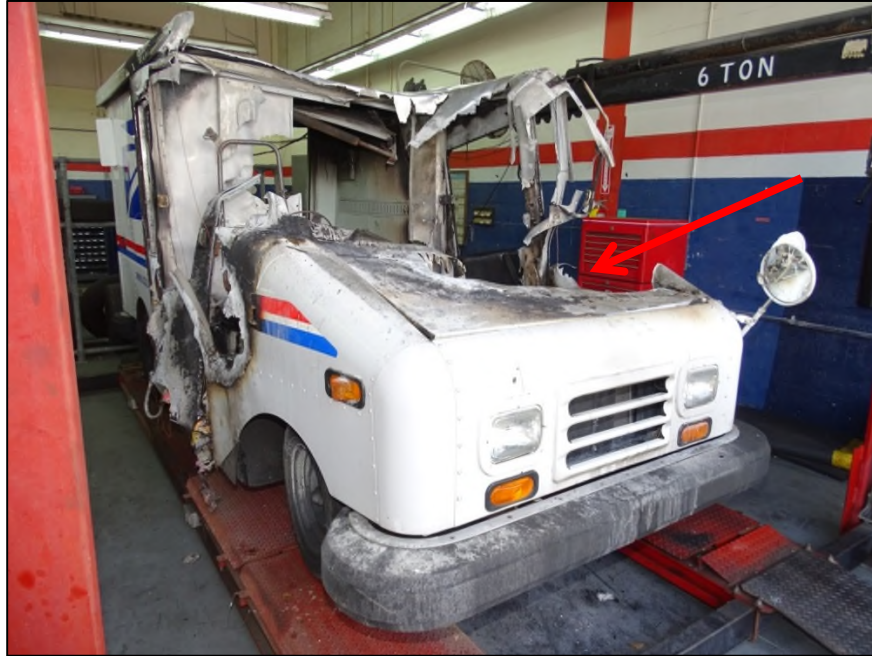
Photograph 1

View of the front operator's side of the 1993 Grumman LLV # 3315220. Note the fire patterns on the mail side of the hood.

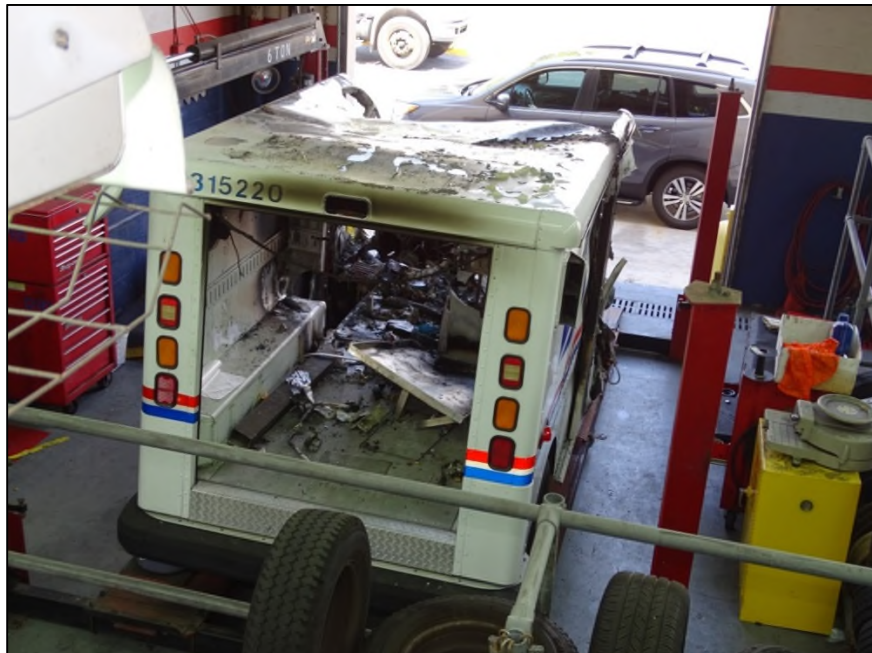
Photograph 2

View of the rear of the vehicle.

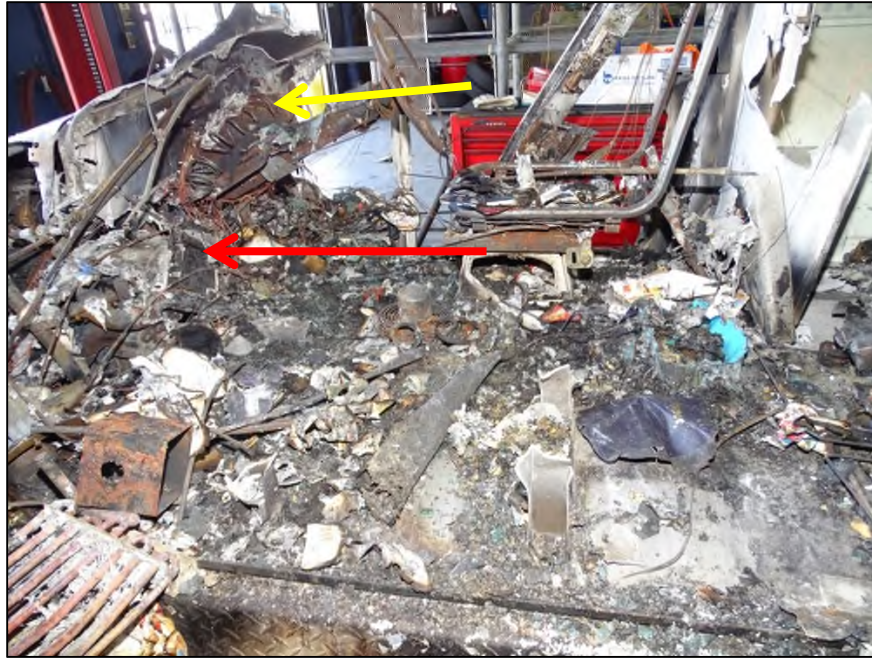
Photograph 3

View of the operator's compartment. Note the position of the fuse pane (yellow) and the ECM (red).

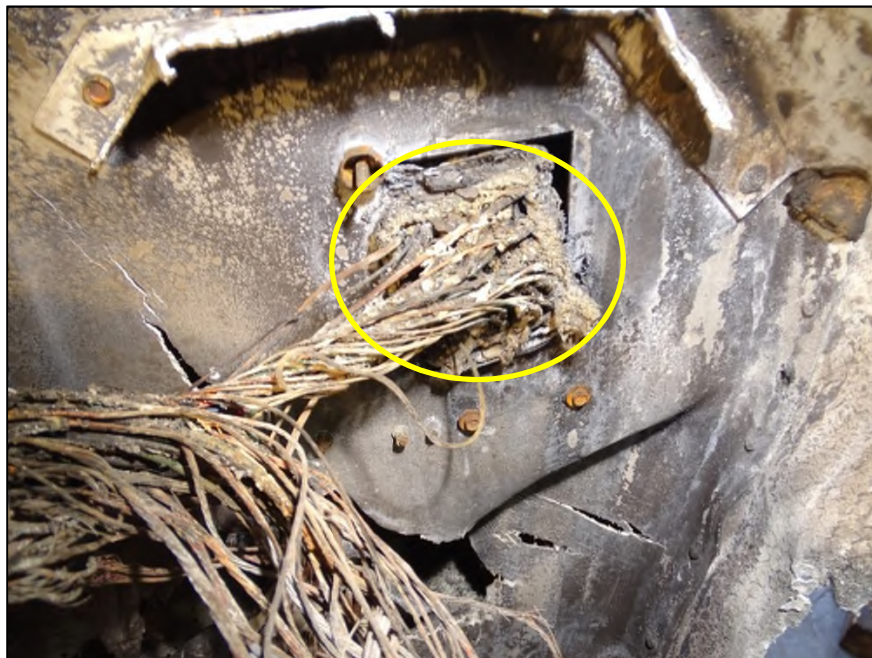
Photograph 4

Closer view of the conductors connected to the fuse panel.

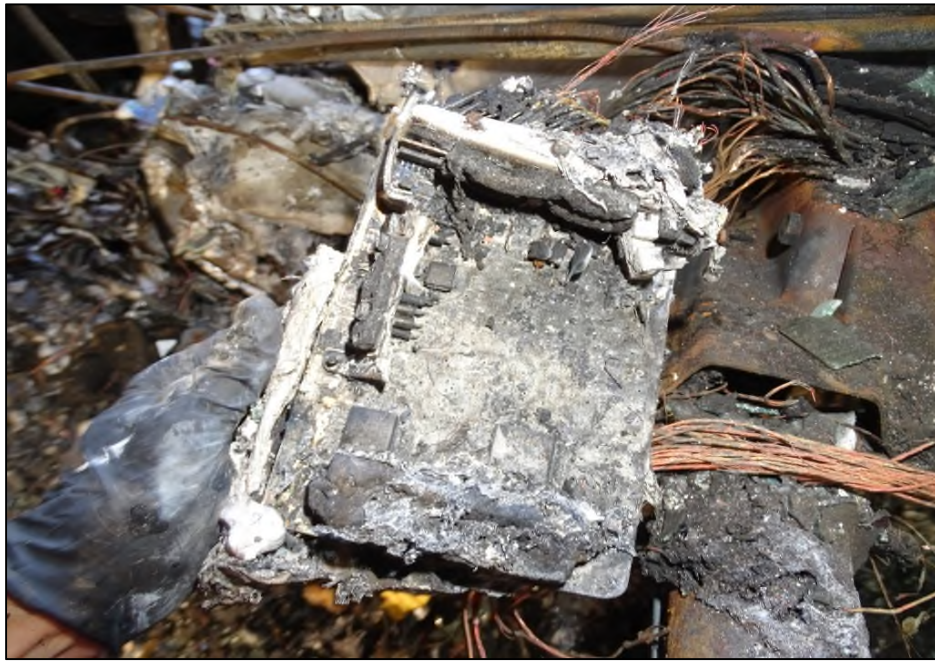
Photograph 5

Closer view of the fire damaged ECM.

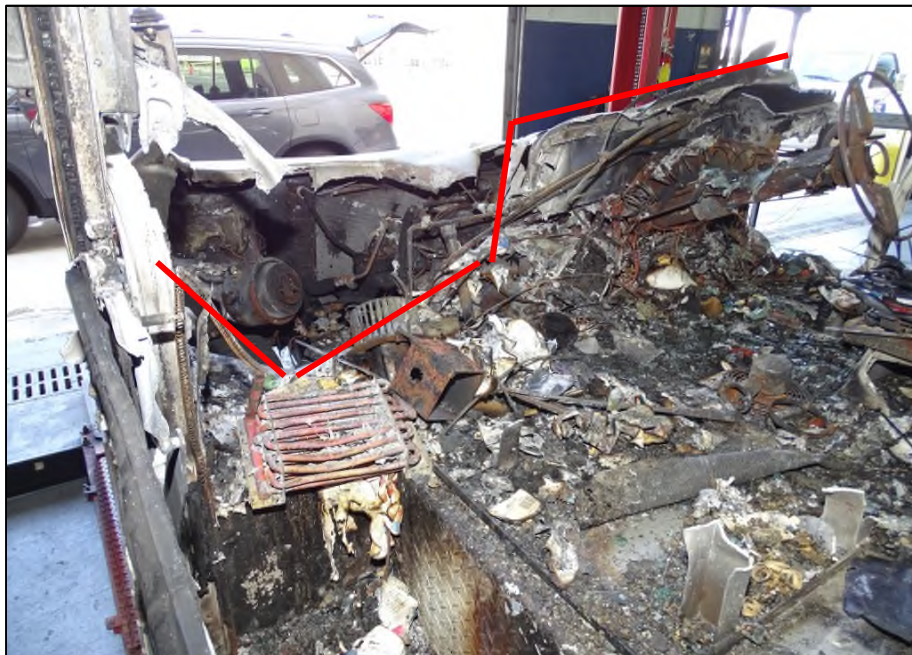
Photograph 6

View of the mail side of the operator's compartment. Note the bulkhead was burned through to the engine compartment while remaining intact on the driver's side.
